ALERT SERVICE BULLETIN

SUBJECT: ELECTRICAL POWER - DC electrical power

Replacement of a power cable belonging to very cold weather starting optional equipment

Corresponds to modification 074838.

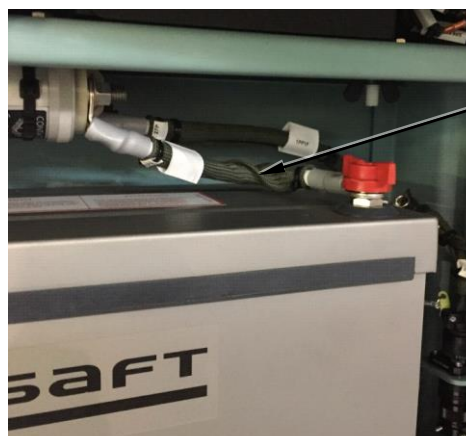
" +BATT" cable

Airbus Helicopters has been notified of a crack case of a lug installed on a power cable of the very cold weather starting optional equipment.

The rupture of this lug may enable the loose power cable to come into contact with an electrical ground. This scenario may cause a short-circuit.

- replacing the "+BATT" cable of the very cold weather start harness with a new cable,

- bonding a teflon tape at the location of the resting point on the structure,
- installing a new polyamide washer and a new polyamide nut on the cable resting point,
- carrying out tests.
