# ALERT SERVICE BULLETIN

**SUBJECT: TIME LIMITS - MAINTENANCE CHECKS - Fan assembly**

**Check of fan assembly bearings**  
ATA 65

Revision No.	Date of issue
Revision 0	2017-07-03

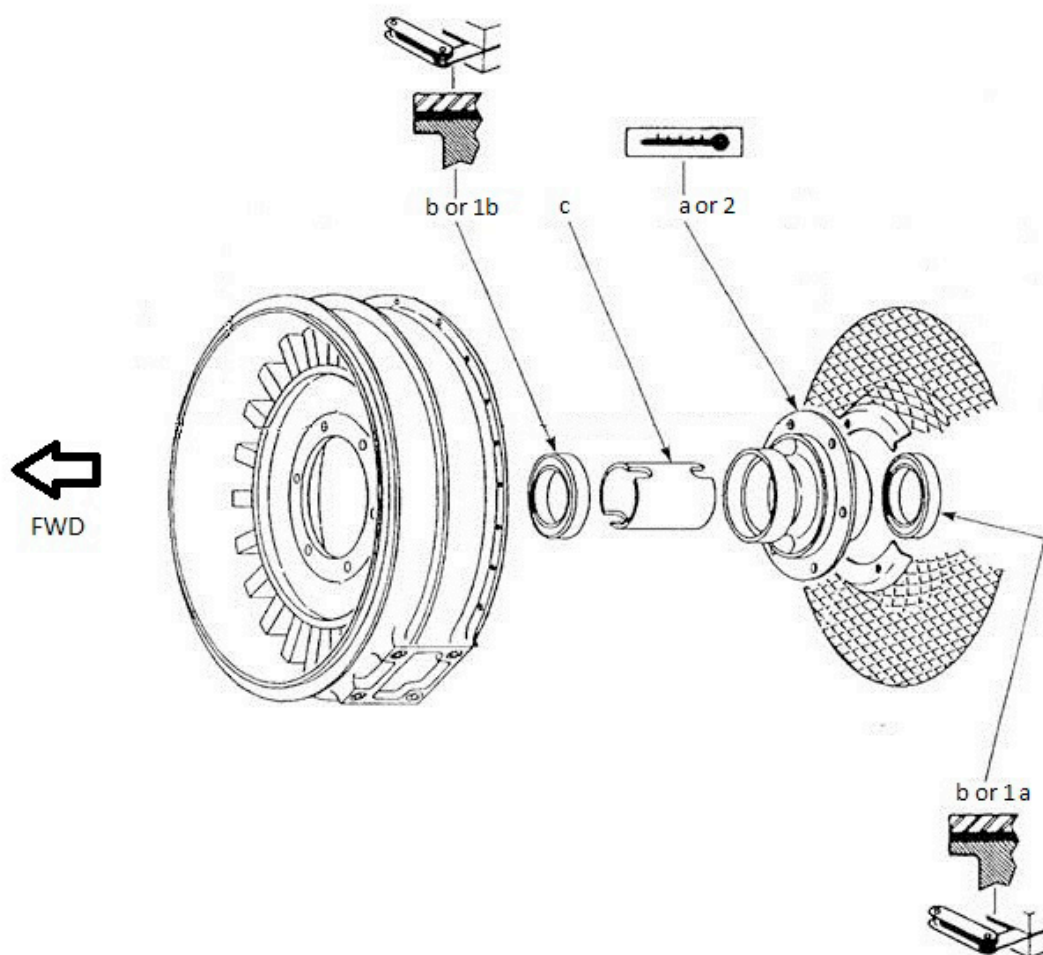
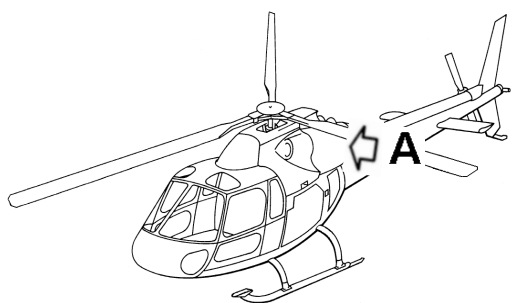
Figure 1

Airbus Helicopters has been informed of a case of deterioration in flight of one of the fan assembly bearings. This deterioration led to the loss of the tail rotor drive.

Following investigations, the deterioration of the bearing is due to premature fouling of the fans that caused an imbalance in the rotation of the tail rotor drive, leading to the loss of the bearing.

- . If the difference is greater than 0.75 ips (Figure 1)
    - Remove the fan assembly as per MET Work Card 65.10.00.401,
    - Remove unit (a) equipped with bearings from the fan assembly,

- Replace former fan bearings (b) with new bearings (1) in accordance with the procedure described in Appendix 4.B. or return unit (a) equipped with bearings for replacement of the fan bearings,

- Install unit (a or 2) equipped with bearings in the fan assembly,
    - Install the fan assembly as per MET Work Card 65.10.00.401,
    - Comply with paragraph 3.B.6.

- Removal of bearings (b):

- . Heat unit (a) equipped with bearings,

**THE UNIT EQUIPPED WITH BEARINGS IS MADE  
OF ALUMINUM. DO NOT HEAT TO A  
TEMPERATURE OF MORE THAN 90°C.**

- . Extract bearings (b) using fan bearing extractor (zz),
  - . Remove spacer (c),
  - . Visually check for correct condition of the removed parts (no wear or fretting) and, if necessary, repair as per MTC.
- Installation of bearings (1) and spacer (c) on unit (a):
- . Place unit (a) in a climatic chamber at 80°C for 30 minutes,
  - . On unit (a), install rear bearing (1a) using fan bearing fitting tool (yy),
  - . On unit (a), install front bearing (1b) and spacer (c) using fan bearing fitting tool (yy),
  - . Let the assembly return to room temperature,
  - . Continue reassembly of the fan assembly as per paragraph 3.B.5.
