ALERT SERVICE BULLETIN

SUBJECT: LIMITATIONS - Control rod double bearing

Tail Gearbox (TGB)

ATA: 65

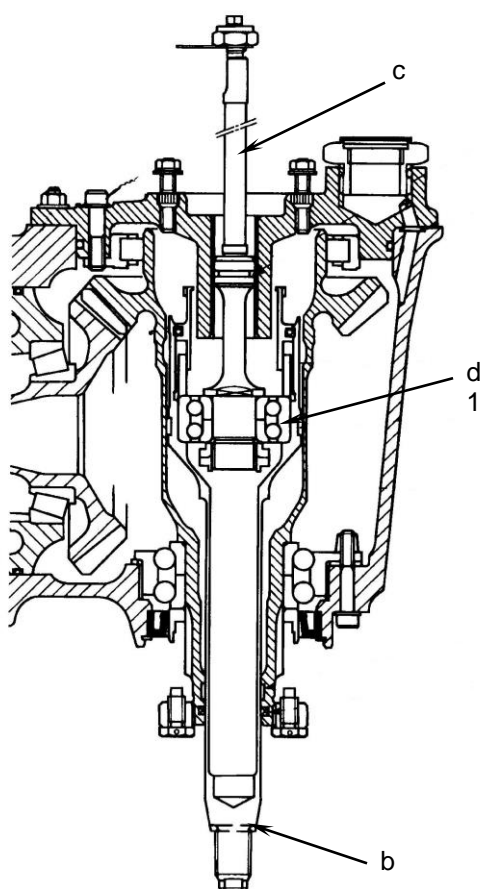
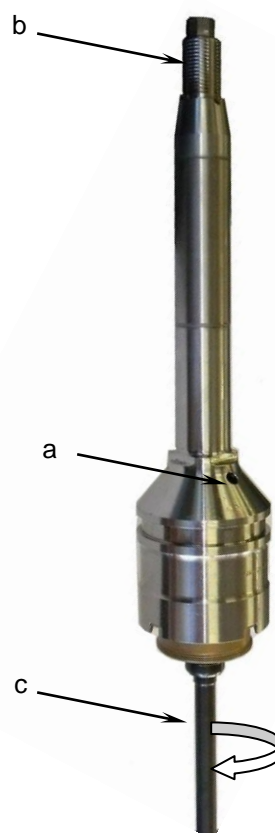
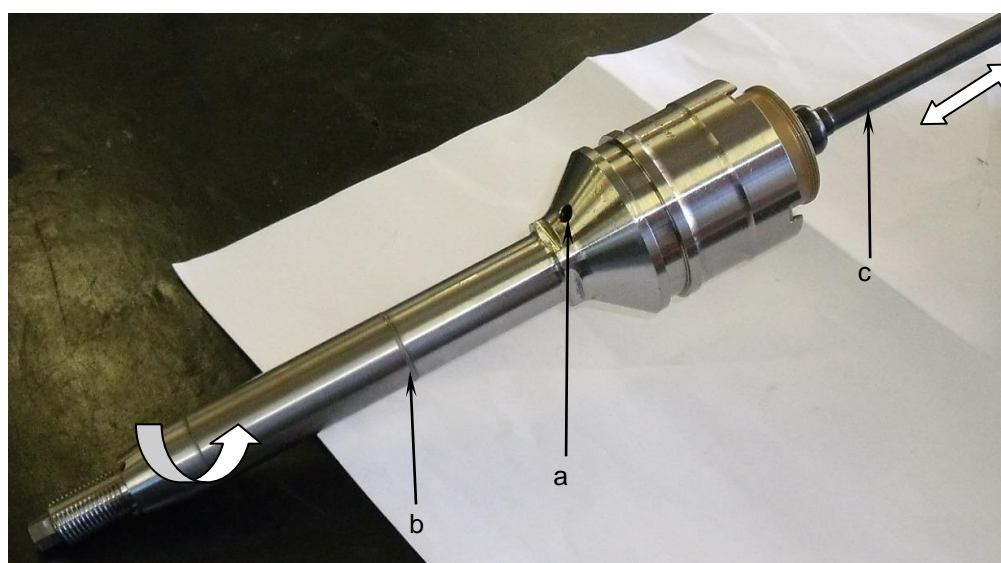
Figure 1

3.B.3. Checking the play in the double bearing of the TGB control shaft/rod assembly (Figure 1)

- Remove the control shaft/rod assembly as per paragraph 3.B.4.a.
- Carry out a tactile check to ensure that there is no axial play in double bearing (d) (Figure 1):
 - . Apply an alternating manual axial load to control rod (c) whilst turning control shaft (b) (**See DETAIL A Figure 1**).

As double bearing (d) is "pre-stressed" by definition, friction points can be felt when turning double bearing (d): they are not critical.

- Clean the control shaft/rod assembly using WHITE SPIRIT (2) as per MTC Work Card 20.04.01.102:
 - . Inject WHITE SPIRIT (2) under pressure (for example using a can) into hole (a) of control shaft (b). (**See Detail B Figure 1**).
 - . Hold shaft (b) in the vertical position pointing upwards.
 - . Manually turn control rod (c) several times to rinse double bearing (d) by draining the WHITE SPIRIT (2) through the bearing. (**See Detail B Figure 1**).
 - . Collect the WHITE SPIRIT (2) on absorbent paper (e.g.: blotting paper):
 - Pass a magnet over the absorbent paper to collect the magnetic particles.

- . Replace double bearing (d) with a double bearing (1) as per AMM Task 65-20-01-961.
- . Install the control shaft/rod assembly as per paragraph 3.B.4.b.
- . **Inform the Airbus Helicopters Customer Service Technical Support Department in accordance with paragraph 2.B.**
- . **Comply with paragraph 2.D.**

- Replace double bearing (d) (Figure 1) with a double bearing (1) as per AMM Task 65-20-01-961.
- Install the control shaft/rod assembly as per paragraph 3.B.4.b.:
 - . **Inform the Airbus Helicopters Customer Service Technical Support Department in accordance with paragraph 2.B.**
 - . **Comply with paragraph 2.D.**
