# ALERT SERVICE BULLETIN

**SUBJECT:** MAIN ROTOR SYSTEM - Main Rotor Head

Rework of the hub cap

Revision No.	Date of issue
Revision 0	2017-04-04

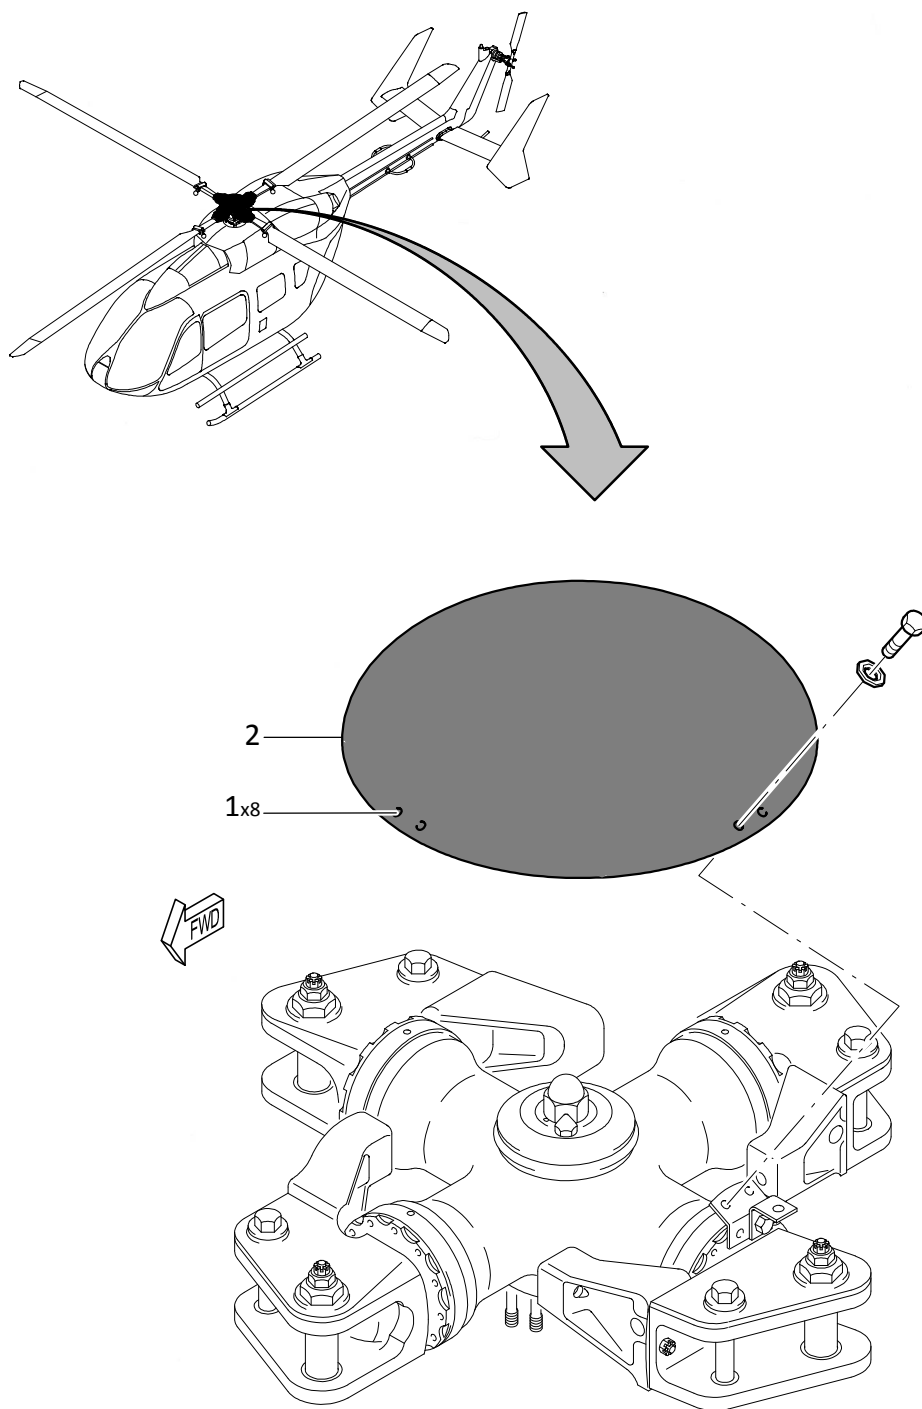
Figure 1

The rework improves the hub cap installation on the main rotor head. The increased bore diameter of all drillings enables a more stress free installation of the hub cap and therefore reduces the risk of cracks in the mounting brackets.

- 1 Borehole      dia. 8.0 mm  
2 Hub cap

1. Drill the eight boreholes (1, Fig. 1) to dia. 8.0 mm.
2. Deburr boreholes (1, Fig. 1).
3. Apply EP primer (CM 436, CM 459, CM 472) to boreholes (1, Fig. 1).
4. Let EP primer dry i.a.w. the manufacturer's instructions.
5. Degrease the area close to the P/N of the hub cap (2, Fig. 1) using dry cleaning solvent (CM 202).
6. Using a permanent pen, identify the hub cap as follows: "ASB MBB-BK117 C-2-62A-010".
7. Protect identification using lacquer, single layer (CM 421) and leave it to dry i.a.w. the manufacturer's instructions.

1. Install the hub cap (2, Fig. 1) i.a.w. AMM, 62-21-02, 4-1.
2. Remove both warning signs from the cockpit.
