# ALERT SERVICE BULLETIN

**SUBJECT:** ROTOR FLIGHT CONTROL - Tail Rotor-, Cyclic- and Collective Controls

**Check bearings for correct attachment and retrofit of bushings and washers**

## Rotor Flight Controls – Tail Rotor, Cyclic and Collective Controls – Check bearings for correct attachment and retrofit of bushings and washers

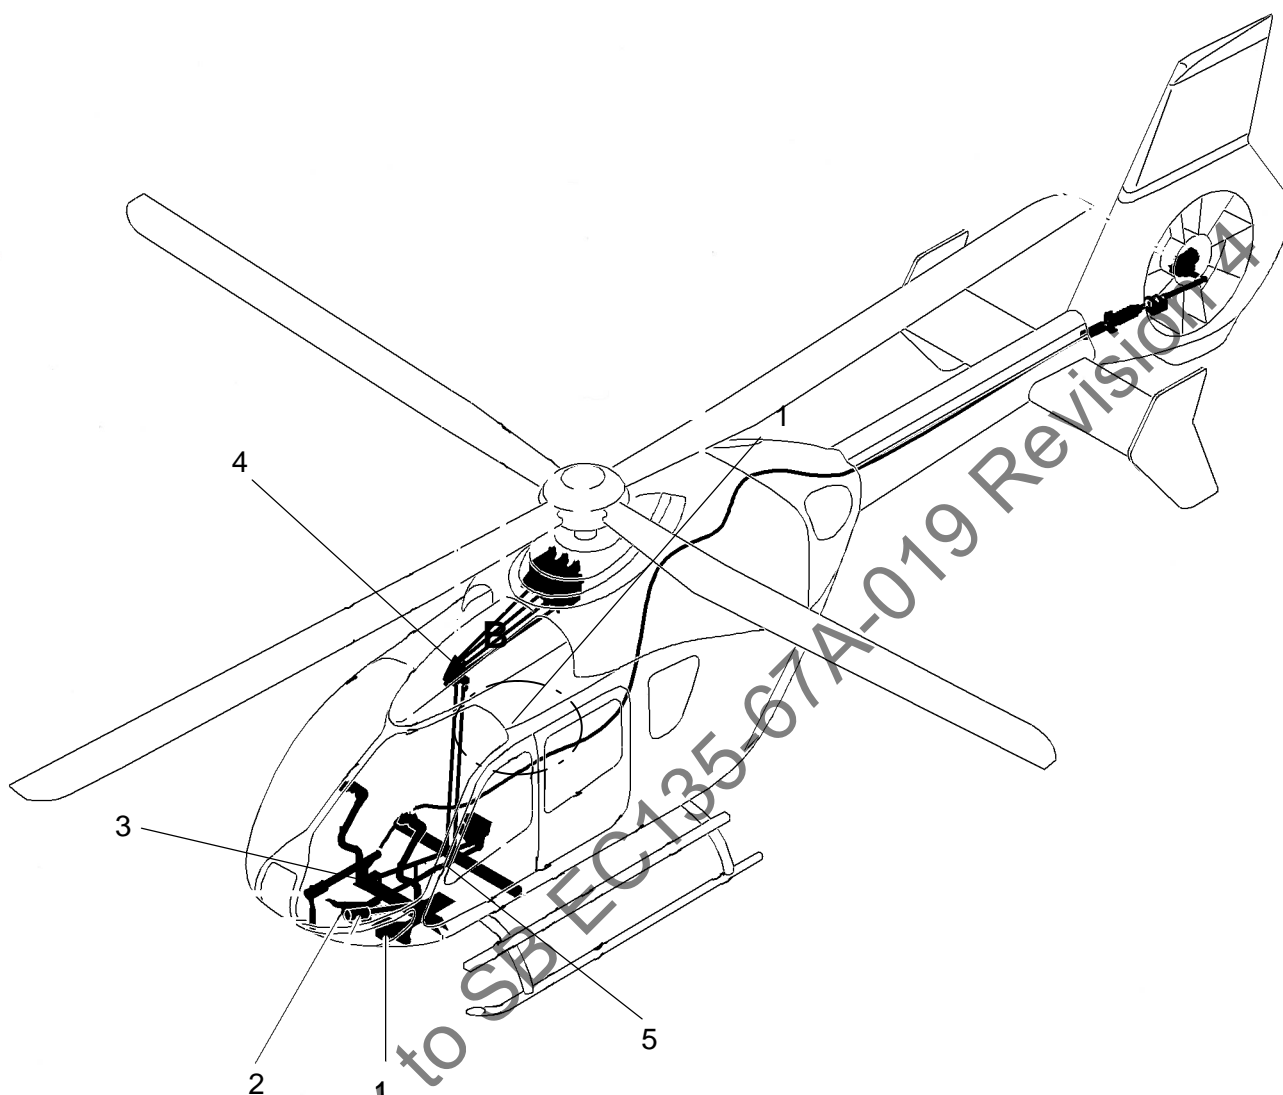
Arrangement of Levers  
Figure 1

- 1 LH guidance unit – Detail A, Figure 2
- 2 RH guidance unit – Detail B, Figure 2
- 3 Lever, cyclic control – Detail C, Figure 3
- 4 Upper guidance unit – Detail D, Figure 3
- 5 LVDT – Detail E, Figure 4

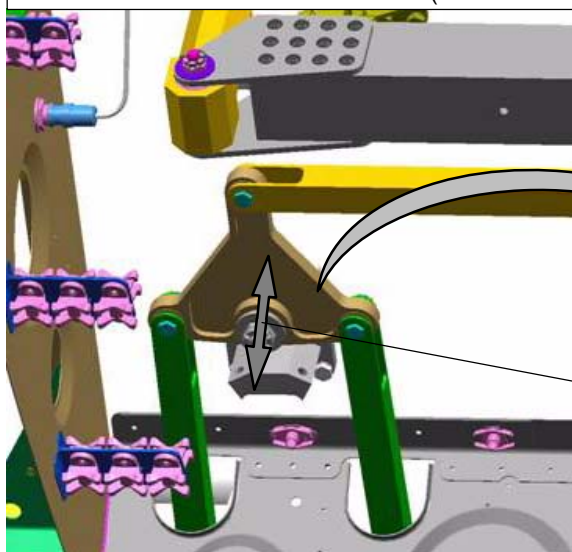
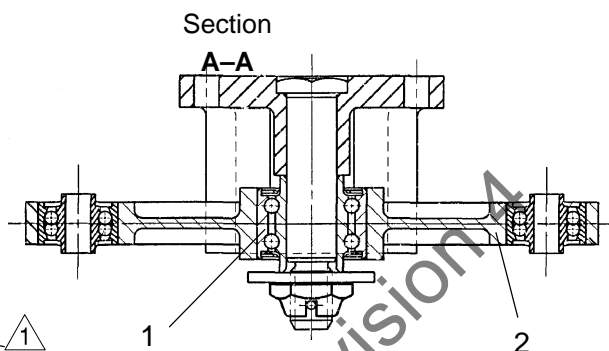
**Detail A** (Overview see Figure 1) **Before** modification

- (1) Check bearing in LH guidance unit (Detail A, Figure 2) for correct attachment.
  - (a) Check, whether bearing (1, Figure 2) is correctly installed in lever (2) as shown in Section A–A.

- (b) Manually check, whether bearing (1) is tightly fitted in lever (2). To do so, manually try to move lever in axial direction  $\triangle$ .
  - (c) If a loose bearing is detected, copy reply form sheet on page 14, fill out and send to ECD customer support. Rebond bearing i.a.w. AMM, 20-00-00, 2-14.

△ 1 Lever must free of play in axial direction.

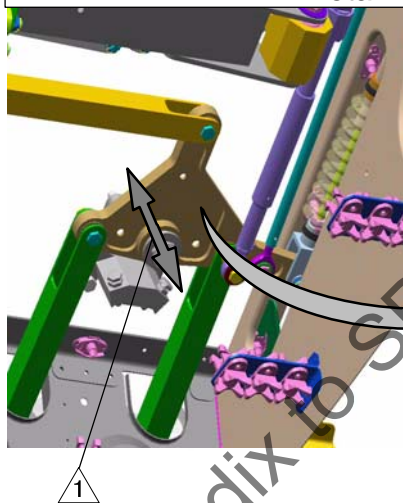
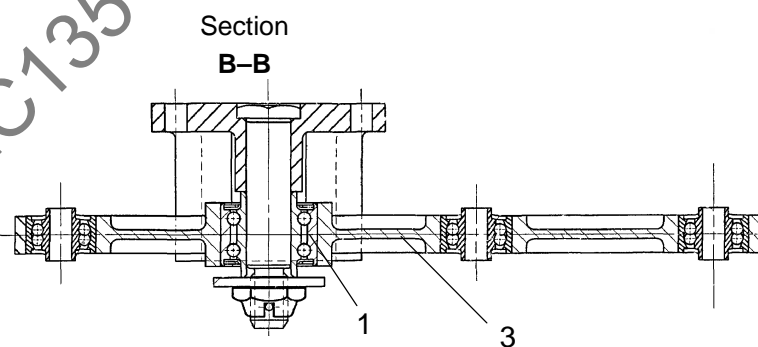
**Detail B** (Overview see Figure 1) **Before** modification

- (2) Check bearing in RH guidance unit (Detail B, Figure 2) for correct attachment.
  - (a) Check, whether bearing (1, Figure 2) is correctly installed in lever (3) as shown in Section B–B.

- (b) Manually check, whether bearing (1) is tightly fitted in lever (3). To do so, manually try to move lever (3) in axial direction  $\triangle$ .
  - (c) If a loose bearing is detected, copy reply form sheet on page 14, fill out and send to ECD customer support. Rebond bearing i.a.w. AMM, 20-00-00, 2-14.

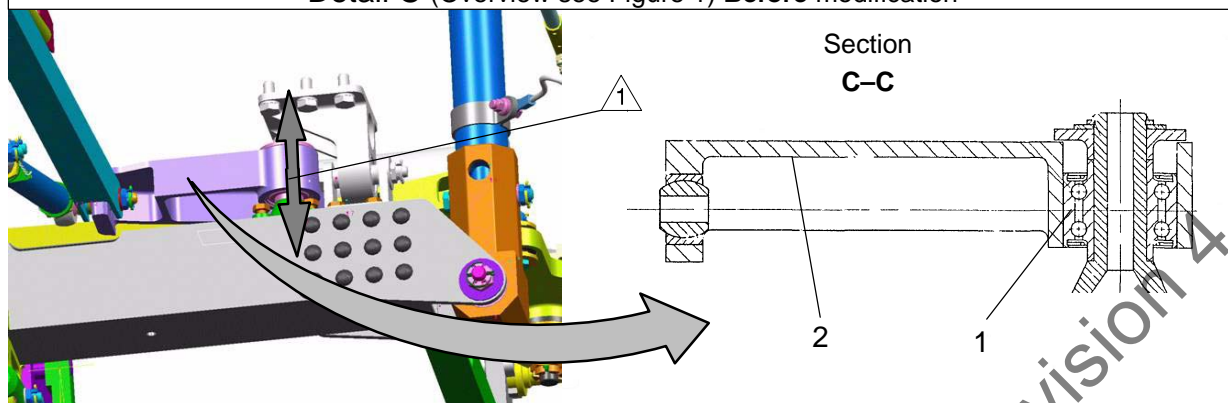
Detail C (Overview see Figure 1) **Before** modification

- (3) Check bearing of cyclic control (Detail C, Figure 3) for correct attachment.
  - (a) Check, whether bearing (1, Figure 3) is correctly installed in lever (2) as shown in Section C–C.

- (b) Manually check, whether bearing (1, Figure 3) is tightly fitted in lever (2). To do so, manually try to move lever in axial direction  $\triangle$ .

- (c) If a loose bearing is detected, copy reply form sheet on page 14, fill out and send to ECD customer support. Rebond bearing i.a.w. AMM, 20-00-00, 2-14.

- △1 Lever must be free of play in axial direction.  
△2 Forked lever must be free of play in axial direction.

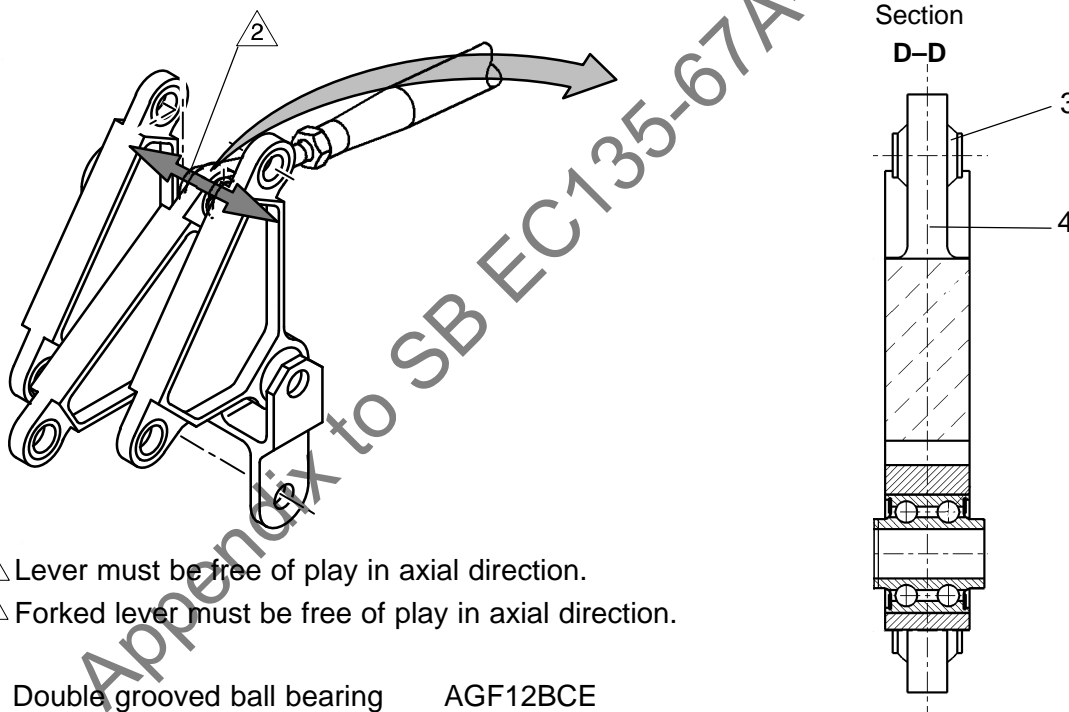
Detail D (see Figure 1) **Before** modification

- (4) Check bearing of upper guidance unit (Detail D, Figure 3) for correct attachment.
  - (a) Check, whether bearing (3, Figure 3) is correctly installed in lever (4) as shown in Section D–D.

- (b) Manually check, whether bearing (3, Figure 3) is tightly fitted in lever (4). To do so, manually try to move connected forked end in axial direction  $\triangle$ .

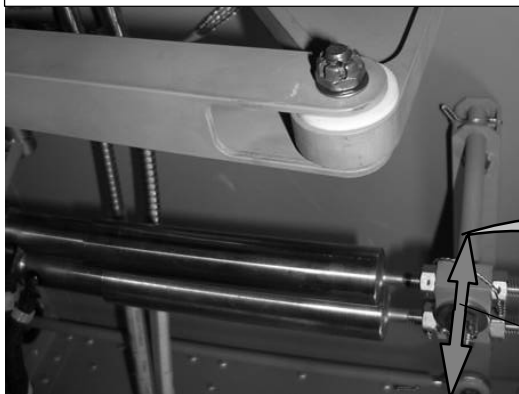
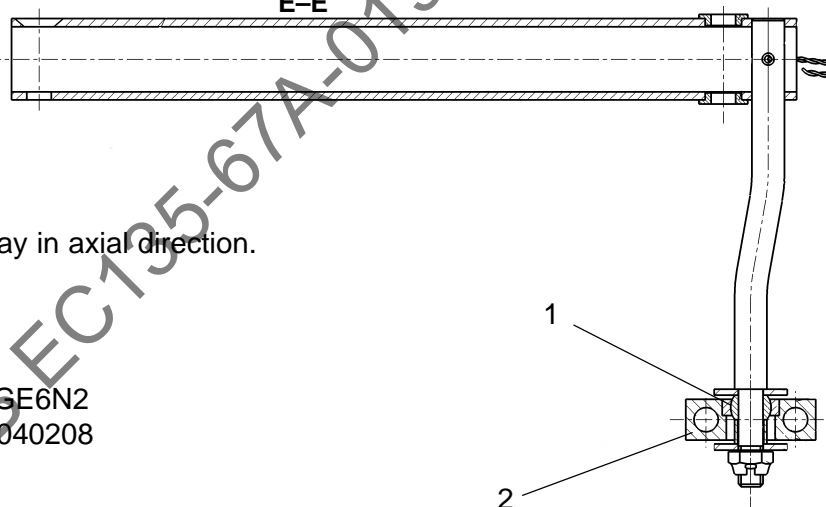
Detail E (see Figure 1)

- (c) If a loose bearing is detected, copy reply form sheet on page 14, fill out and send to ECD customer support. Rebond bearing i.a.w. AMM, 20-00-00, 2-14.
- (5) Check bearing in LVDT plate (Detail E, Figure 4) for correct attachment.
  - (a) Check, whether bearing (1, Figure 4) is correctly installed in plate (2) as shown in Section E-E.
  - (b) Manually check, whether bearing (1, Figure 4) is tightly fitted in plate (2). To do so, manually try to move plate (2) in axial direction  $\triangle$ .
  - (c) If a loose bearing is detected, copy reply form sheet on page 14, fill out and send to ECD customer support. Rebond bearing i.a.w. AMM, 20-00-00, 2-14.

△ Plate (2) must be free of play in axial direction.
