ALERT SERVICE BULLETIN

SUBJECT: OPTIONAL EQUIPMENT - External Mounted Hoist

Unintended detachment of hook assembly from the cable

ASB EC135-85A-069

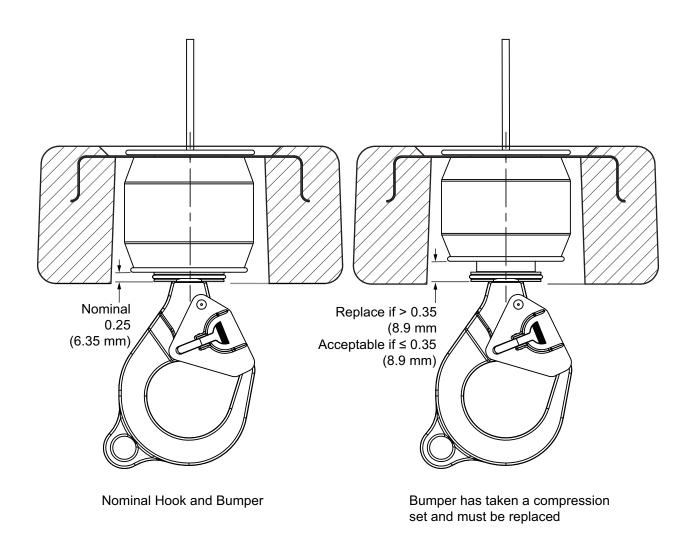
Figure 1. Hook bumper compression

It was observed that a hook separated from the cable. This was caused by a dual failure; an internal retaining ring failed and the elastomeric energy absorber (the bumper) took a compression set. The retaining ring can corrode in a salt-laden environment. This Service Bulletin provides instructions for the periodic inspection of hook components to prevent separation of the hook from the cable.

- B. Within five minutes of reeling out the cable in step 2.A, measure the elastomeric energy absorber (bumper) to verify that it hasn't taken a permanent compression set (ref Figure 1).

- If the bumper has taken a permanent compression set, install a new bumper, P/N 42305-290. Refer to CMM 25-00-21-1 for replacement instructions.
- Remove the hook assembly (35, Figure 2) by removing the spring retainer (5) and unscrewing the hook carrier (10) from the body of the hook assembly and set aside.

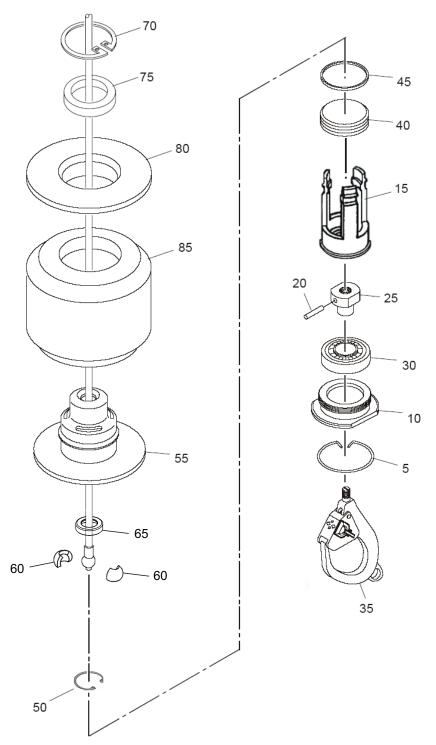
Figure 2. Hook Assembly 44301-420, -423

CAUTION: LOSS OF THE RETAINING RING CAN CONTRIBUTE TO SEPARATION OF THE HOOK FROM THE HOIST CABLE, POSSIBLY LEADING TO LOSS OF THE CABLE LOAD.

- E. Push the hoist cable into the cable hook retainer (15. Figure 2) and remove the seal cap (40) with attached o-ring (45).
- F. Remove and discard the retaining ring (50).

- If removed, install the spherical seat retainer ring (65, Figure 2) and the split cable retainer (60) on the swaged ball end of the rescue hoist cable. Use the rescue hoist cable to pull the spherical seat retainer ring (65) and the split cable retainer (60) into the lower disc (55). Make sure the assembly is bottomed out in the lower disc (55).

- Install a new retaining ring (50, Figure 2). Visually inspect retaining ring (50) after installation to make sure it is securely installed in its retaining groove (see Figure 3).
- Install the assembled seal cap (40, Figure 2) with o-ring (45) into the lower disc (55). Make I. sure the o-ring (45) is not damaged during installation.
- Reinstall the hook by screwing the carrier into the retainer (15, Figure 2) and installing the J. spring retainer (5).
 - NOTE: The two parts of the carrier (10) and (15) are a matched set (MSL #). When reassembling the carrier, do not intermix components between hook assemblies.
- K. Apply power to the hoist and reel in the hook to the home position. Remove power from the hoist.
