# EMERGENCY ALERT SERVICE BULLETIN

**SUBJECT:** MAIN ROTOR - Rotor mast

**Check of the rotor mast oil pipe**  
ATA 62

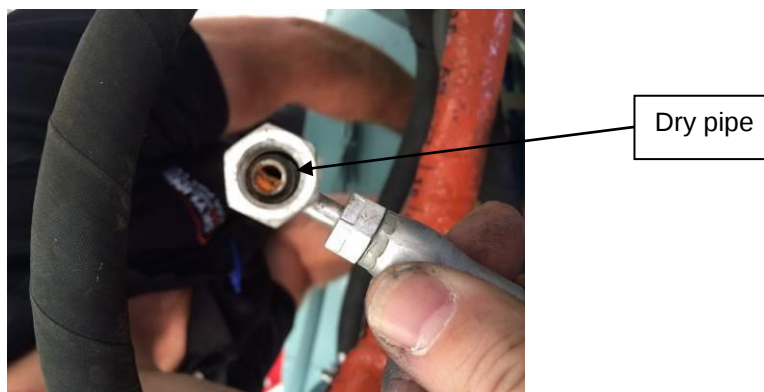
During replacement of a pipe which ensures the lubrication of the rotor mast bearings, this pipe was found to be obstructed. There was no oil on the upper union of the pipe (See photos below).

Analysis revealed that this obstruction is due to a solder run which occurred during soldering of the lower union of the pipe, thus making the oil flow impossible.

The lack of lubrication may affect the operation of the main rotor mast bearings.

Compliance with this ALERT SERVICE BULLETIN consists in ensuring that the main rotor mast lubrication pipe is not obstructed.

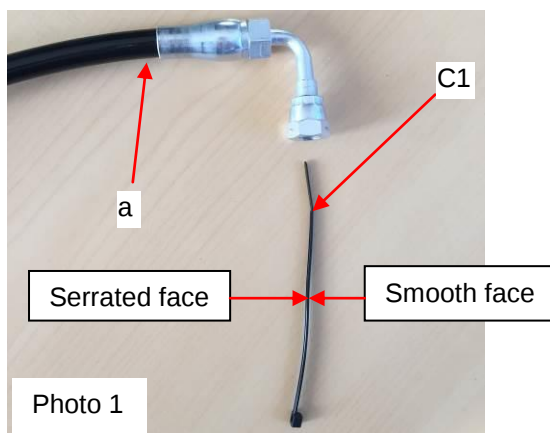
. position pipe (a) and cable tie (C1) (see photo 1),

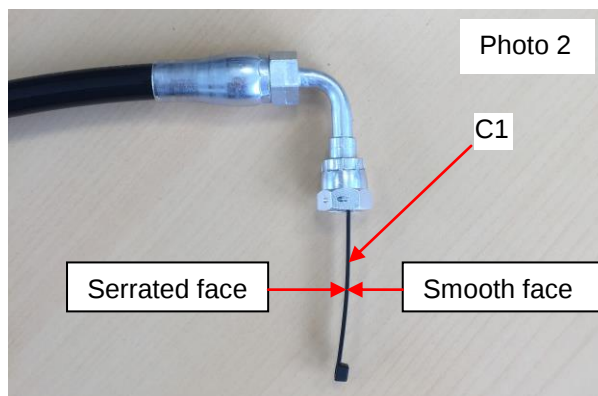
. insert cable tie (C1) as far as possible into pipe (a) (see photo 2),

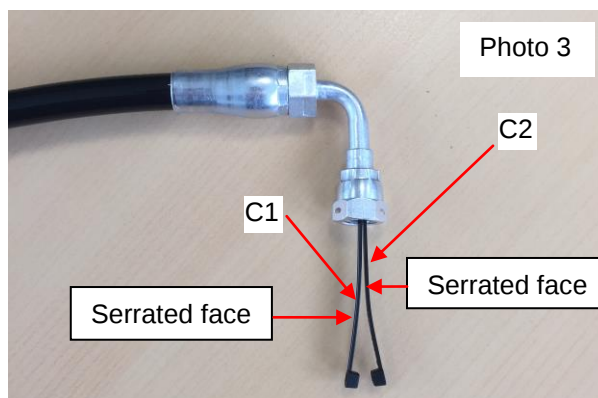
. insert cable tie (C2) as far as possible into pipe (a) (see photo 3),

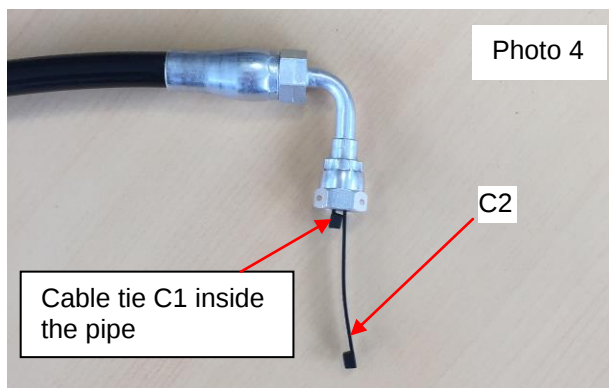
- . push cable tie (C1) into pipe (a) over its full length (see photo 4),

*Cable tie (C2) is used as a guide to facilitate the penetration of cable tie (C1) in pipe (a).*
