EMERGENCY ALERT SERVICE BULLETIN

SUBJECT: TIME LIMITS - MAINTENANCE CHECKS - Upper fin

Inspection of the spar and attachment screws of the upper fin
 ATA: 55

HELICOPTER(S) CONCERNED	NUMBER	Version(s)	
		Civil	Military
AS350	05.00.90	B3	/
AS355	05.00.76	E, F, F1, F2, N, NP	/
AS550	05.00.66	/	C3
AS555	05.00.56		AF, AN, AP, SN, UF, UN

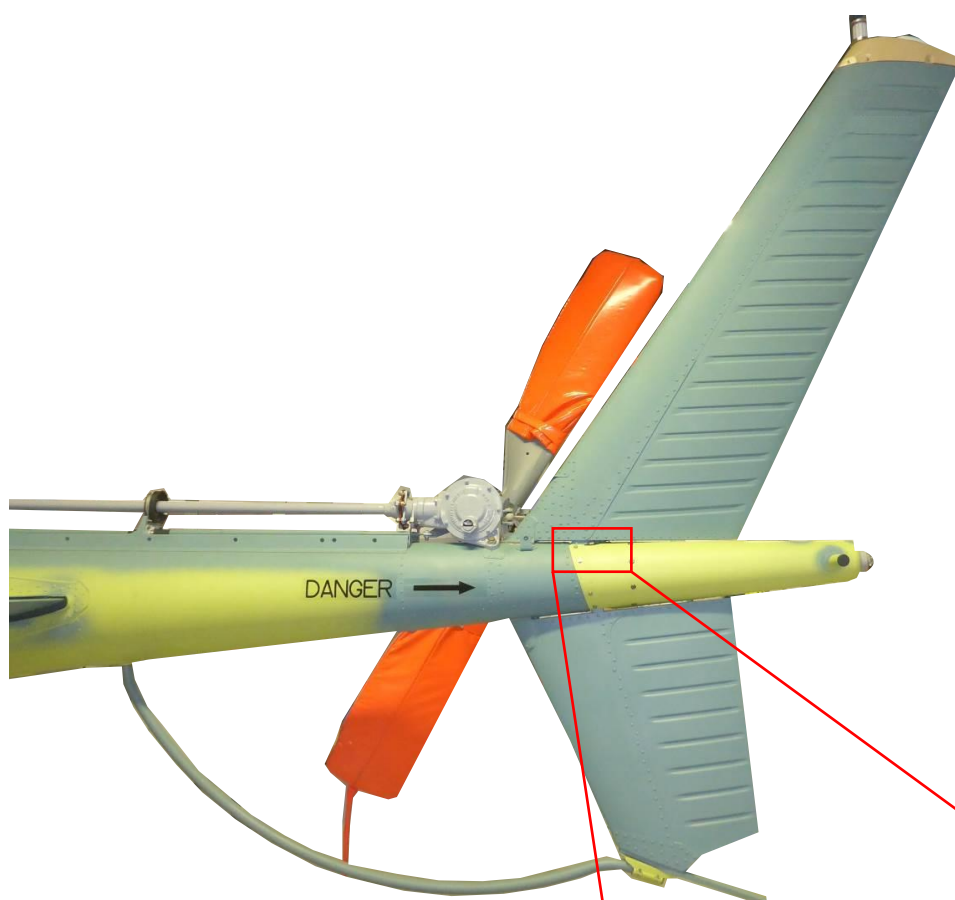
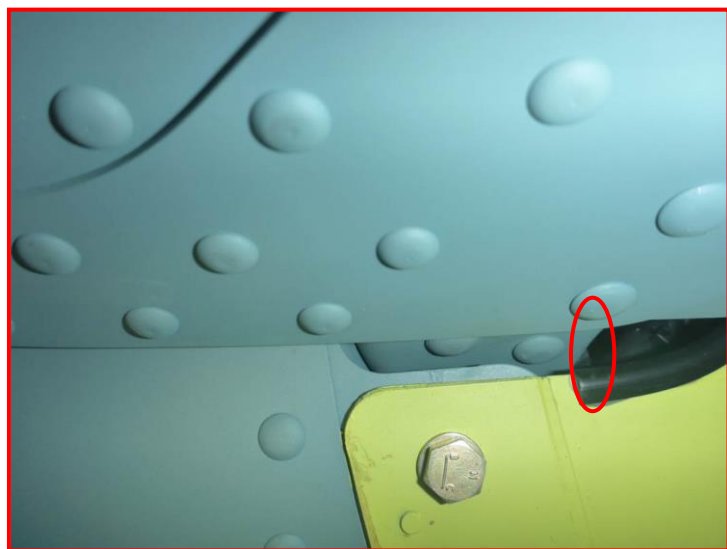
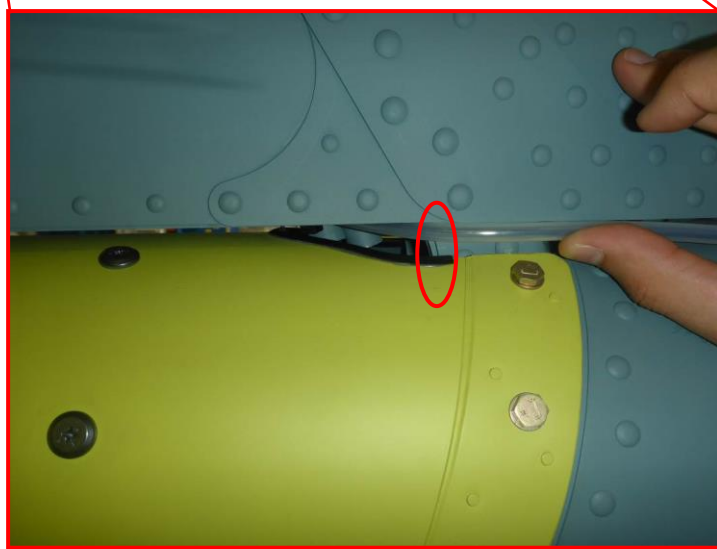
Figure 1: visual inspection

3.B.2. Visual inspection (Figure 1)

- Without removing the rear fairing, visually check that there are no cracks on the LH and RH sides of spar (a) (see [Figure 2](#)):
 - . If in doubt, remove the rear fairing to perform a detailed inspection and carry out a dye-penetrant inspection as per MTC Work Card 20.02.09.601:
 - .. If there are no cracks, leave as is.
 - .. Otherwise, **before resuming flights**, contact the Airbus Helicopters Customer Service Technical Support as per Note 1 to request a repair solution.
- Perform the final steps as per [paragraph 3.B.4.](#)

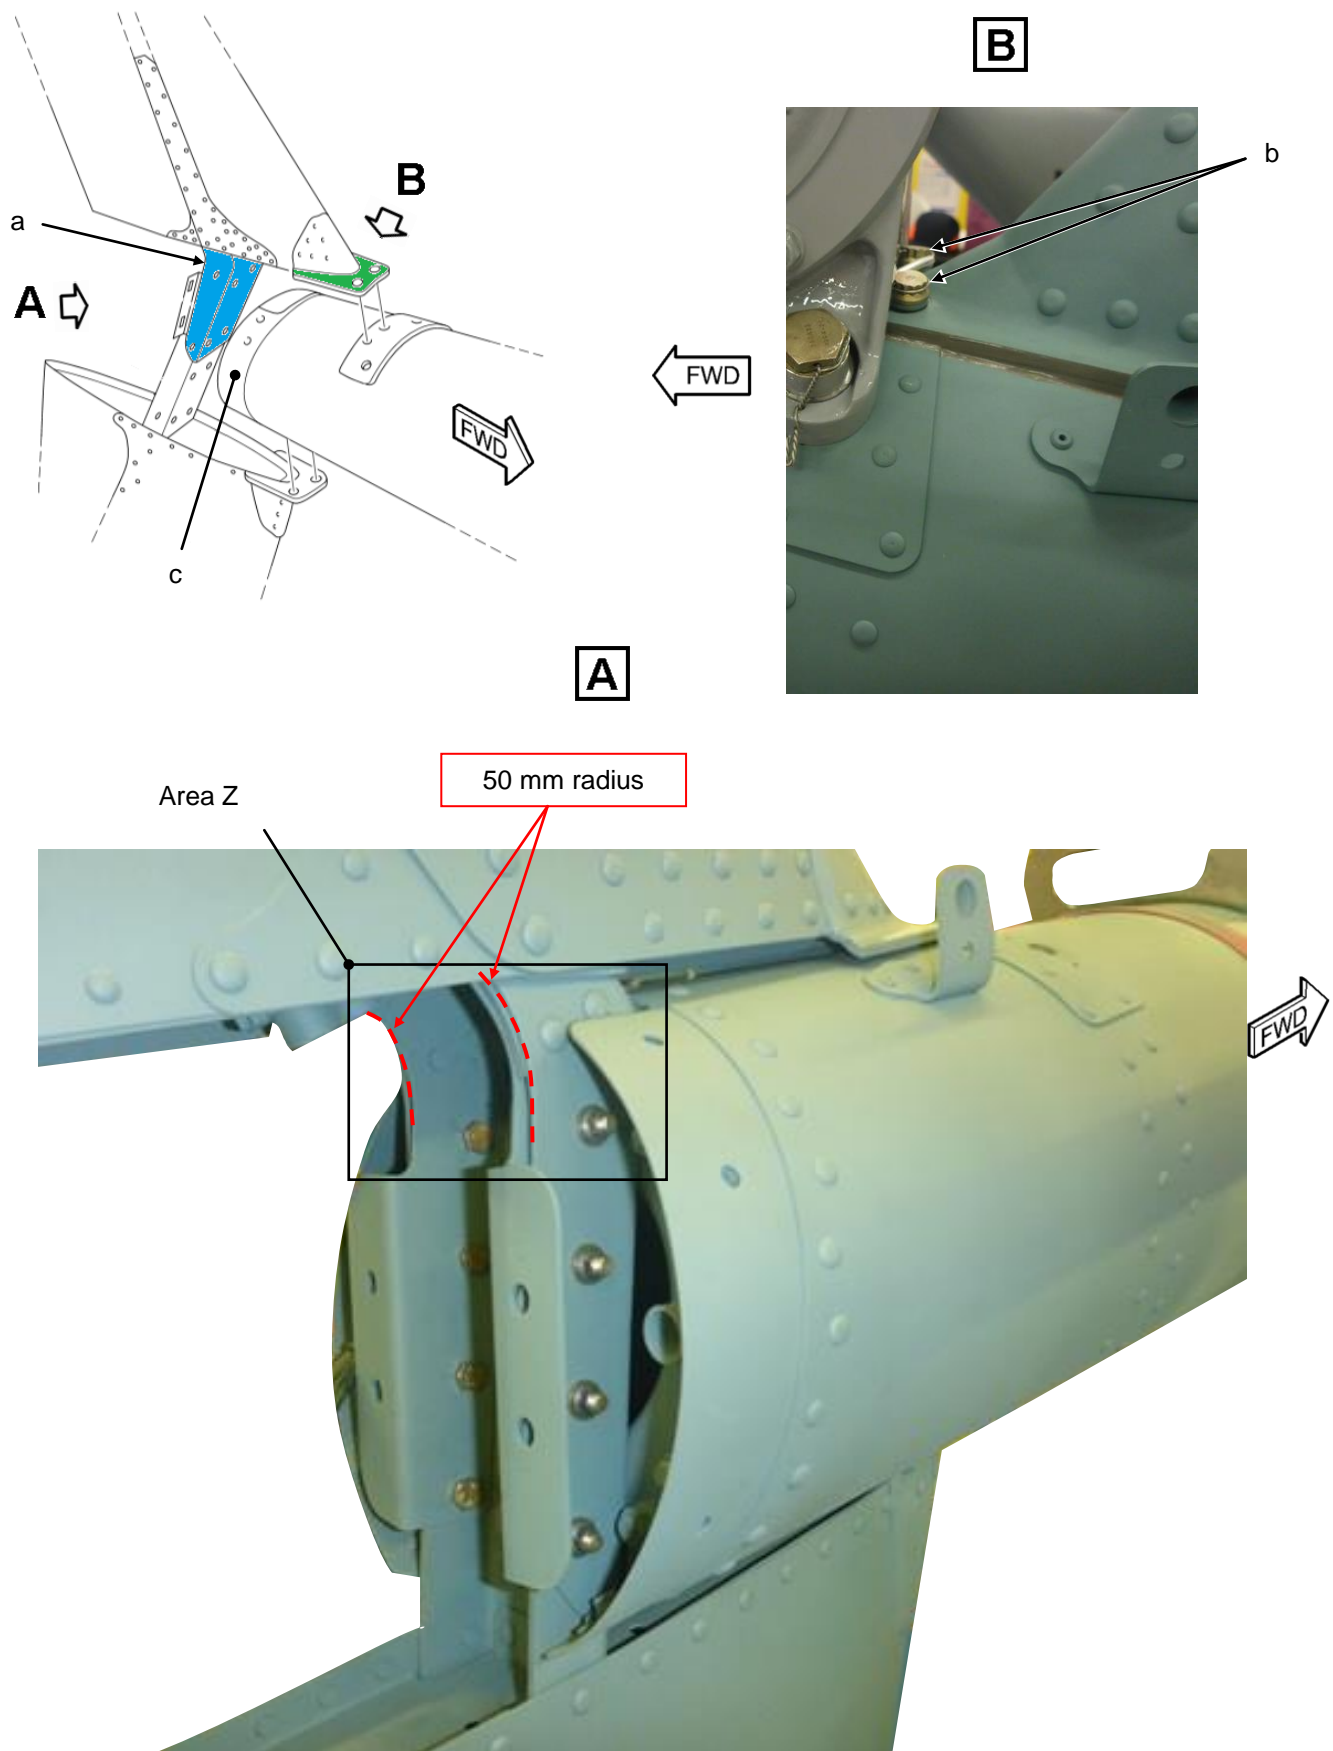
- Remove the rear fairing from the tail boom.
- Disconnect the cut-off connector of the tail position light.
- Clean spar (a) ([Figure 2](#)), Area Z ([Detail A](#), Figure 2) and the heads of attachment screws (b) ([Detail B](#), Figure 2) of the upper fin as per MTC Work Card 20.04.01.102.
- Visually check for cracks in spars (a) of the upper and lower fins (see example of crack as per [Figure 3](#)) as per MET Work Card 55.00.00.601 or AMM Task 55-20-00, 6-3:
 - . If in doubt, carry out a dye-penetrant inspection as per MTC Work Card 20.02.09.101:

**PAY PARTICULAR ATTENTION TO THE 50 MM
RADIUS, SEE AREA Z, [DETAIL A](#).**

- . If there are no cracks, leave as is.
- . Otherwise, **before resuming flights**, contact the Airbus Helicopters Customer Service Technical Support as per the Note.
- Check the integrity of the two thrust pad attachment screws (b) ([Detail B](#), Figure 2):
 - . If no damage is found, leave as is.
 - . Otherwise, **before resuming flights**, contact the Airbus Helicopters Customer Service Technical Support as per Note 2.

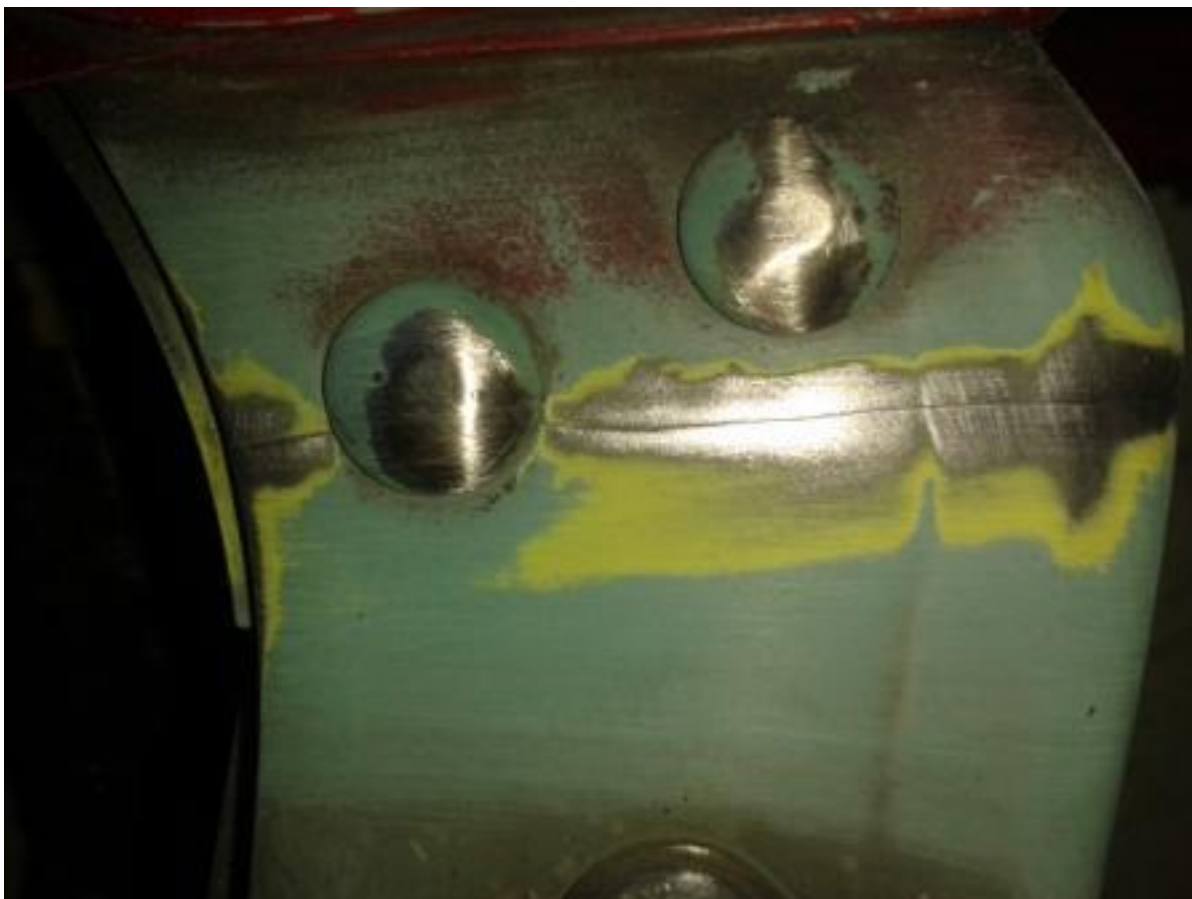
Figure 3: example of a crack in the spar of the upper fin

Inspections revealed a crack in the spar of the upper fin and the fracture of the two front attachment screws of the fin.
