# EMERGENCY ALERT SERVICE BULLETIN

**SUBJECT:** MAIN ROTOR - Rotor mast

**Check of the rotor mast oil pipe**  
ATA 62

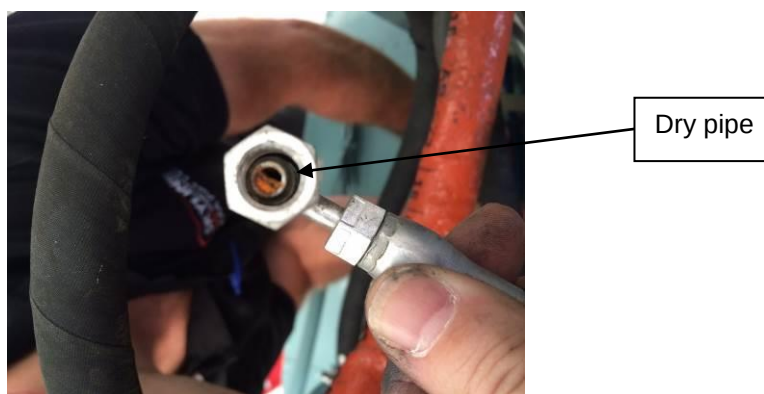
During replacement of a pipe which ensures the lubrication of the rotor mast bearings, this pipe was found to be obstructed. There was no oil on the upper union of the pipe (See photos below).

Analysis revealed that this obstruction is due to a solder run which occurred during soldering of the lower union of the pipe, thus making the oil flow impossible.

The lack of lubrication may affect the operation of the main rotor mast bearings.

Compliance with this ALERT SERVICE BULLETIN consists in ensuring that the main rotor mast lubrication pipe is not obstructed.
