# ALERT SERVICE BULLETIN

SUBJECT: FLIGHT CONTROL SYSTEM - Main Rotor Controls

Removal of the swashplate bellows and retrofit of the deflection ring of the swashplate

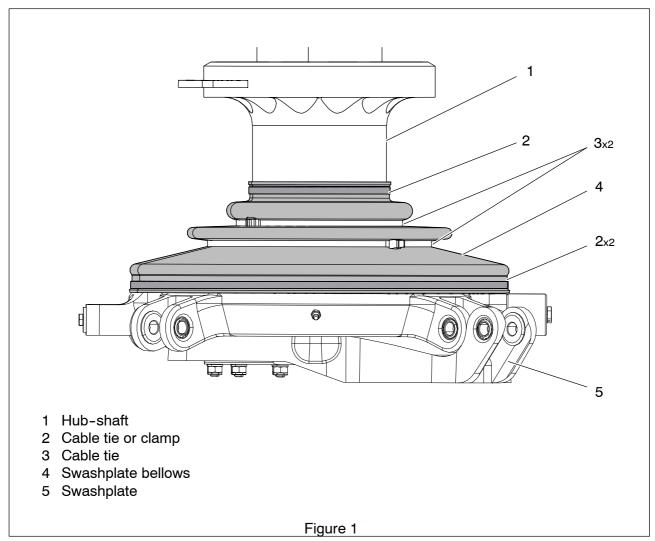
- (a) Remove the cable ties or clamps (2, Fig. 1) and cable ties (3) from the swashplate bellows (4).
- (b) Remove the swashplate bellows (4, Fig. 1) from the swashplate (5) and from the hub-shaft (1).
- (c) Discard the swashplate bellows (4, Fig. 1).

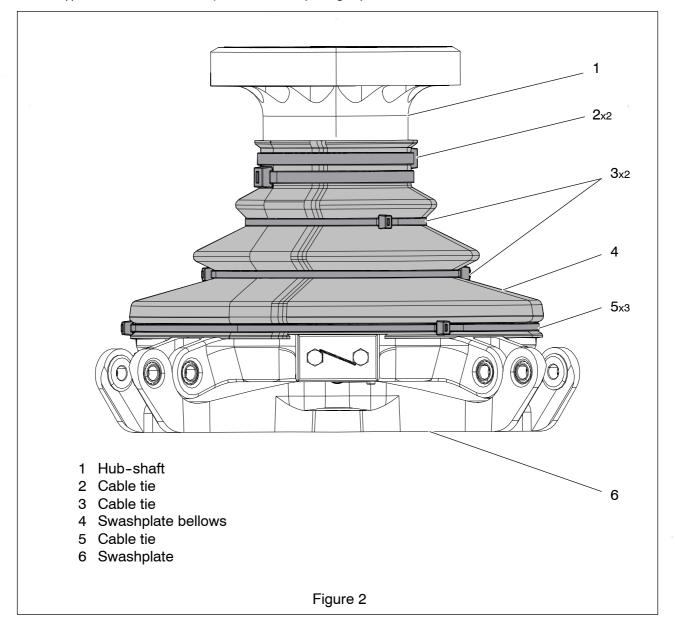
- (d) Remove the cable ties (2, Fig. 2), cable ties (3) and cable ties (5) from the swashplate bellows (4).
- (e) Remove the swashplate bellows (4, Fig. 2) from the swashplate (6) and from the hub-shaft (1).
- (f) Discard the swashplate bellows (4, Fig. 2).

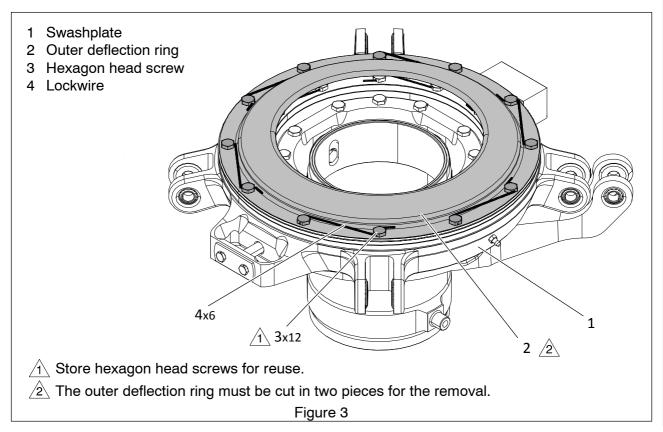
- (a) Remove the lockwire (4, Fig. 3) from the hexagon head screws (3).
- (b) Remove the twelve hexagon head screws (3, Fig. 3) from the swashplate (1). Store the hexagon head screws (3) for reuse.

- (c) Protect the swashplate (1, Fig. 3) with a cloth.
- (d) Cut the outer deflection ring (2, Fig. 3) in two pieces using a metal snips or a suitable tool.
- (e) Remove the outer deflection ring (2, Fig. 3) from the swashplate (1).
- (f) Discard the outer deflection ring (2, Fig. 3).

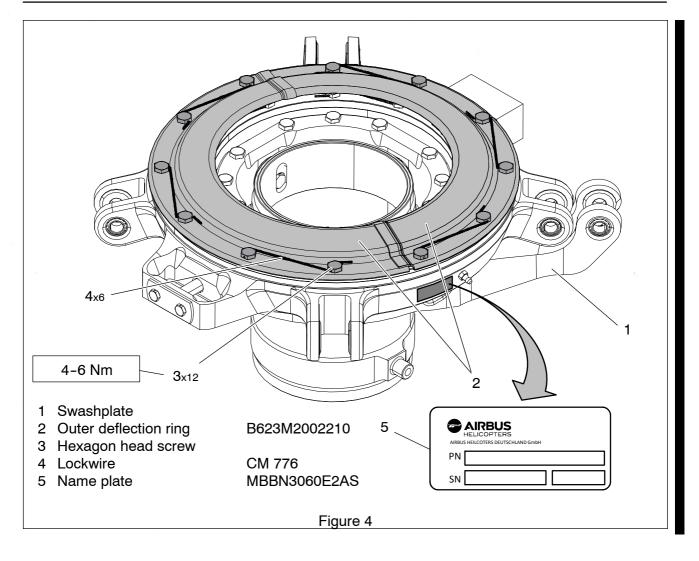
- (g) If there are unwanted objects in the area where the old deflection ring was installed, remove the unwanted objects. Remove dirt with a lint-free cloth.
- (h) Position both parts of the new outer deflection ring (2, Fig. 4) on the swashplate (1), refer to Fig. 4.
- (i) Install both parts of the new outer deflection ring (2, Fig. 4) with twelve hexagon head screws (3). Torque the hexagon head screws (3) to 4–6 Nm (36–53 lbf.in).
- (j) Secure the Hexagon head screws (3, Fig. 4) with lockwire (4) (CM 776).

(I) Write the P/N "105-41904-001" on the new name plate (5, Fig. 4) using a wiping resistant pen.

(m) Write the P/N "105-41905-001" on the new name plate (5, Fig. 4) using a wiping resistant pen.

- (n) Copy the S/N from the old name plate to the new name plate (5, Fig. 4) using a wiping resistant pen.
- (o) Cross out the old P/N on the old name plate.
- (p) Apply a layer of lacquer (CM 481) to the old name plate. Let lacquer dry i.a.w manufacturer's instruction.
- (g) Install the new name plate (5, Fig. 4) close to the old name plate to the swashplate (1).
- (r) Apply a layer of laquer (CM 481) to the new name plate (5, Fig. 4). Let laquer dry i.a.w manufacturer's instruction.

- (s) Use a wiping resistant pen, identify the swashplate close to the name plate (5, Fig. 4) as follows: "ASB BO105-40A-107".
- (t) Protect the identification with lacquer, single-layer (CM 421). Leave lacquer, single layer dry, refer to the manufacturer's instructions.

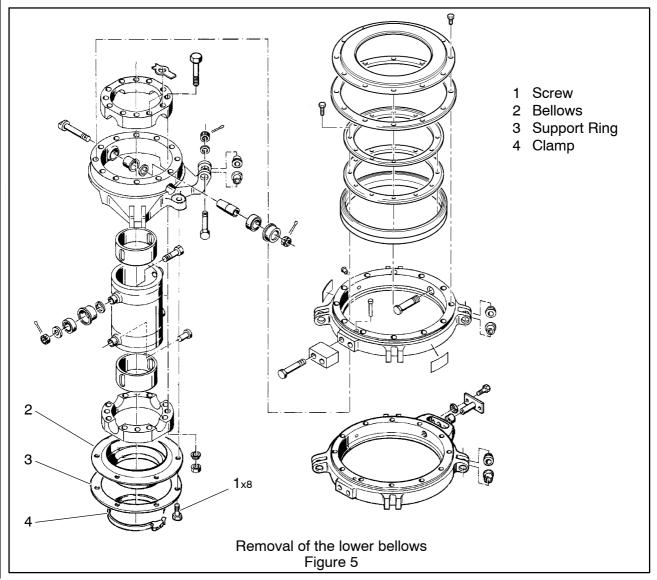
- (a) Remove the lock wire from the screws (1, Fig. 5).
- (b) Remove the screws (1, Fig. 5) from the swashplate.
- (c) Remove the clamp (4, Fig. 5) from the lower bellows (2).
- (d) Cut the support ring (3, Fig. 5) in two pieces using a metal snips or a suitable tool.
- (e) Cut the lower bellows (2, Fig. 5) using a suitable tool.
- (f) Remove the lower bellows (2, Fig. 5) and the support ring (3) from the swashplate.
- (g) Discard the lower bellows (2, Fig. 5), the support ring (3) the clamp (4) and the screws (1).

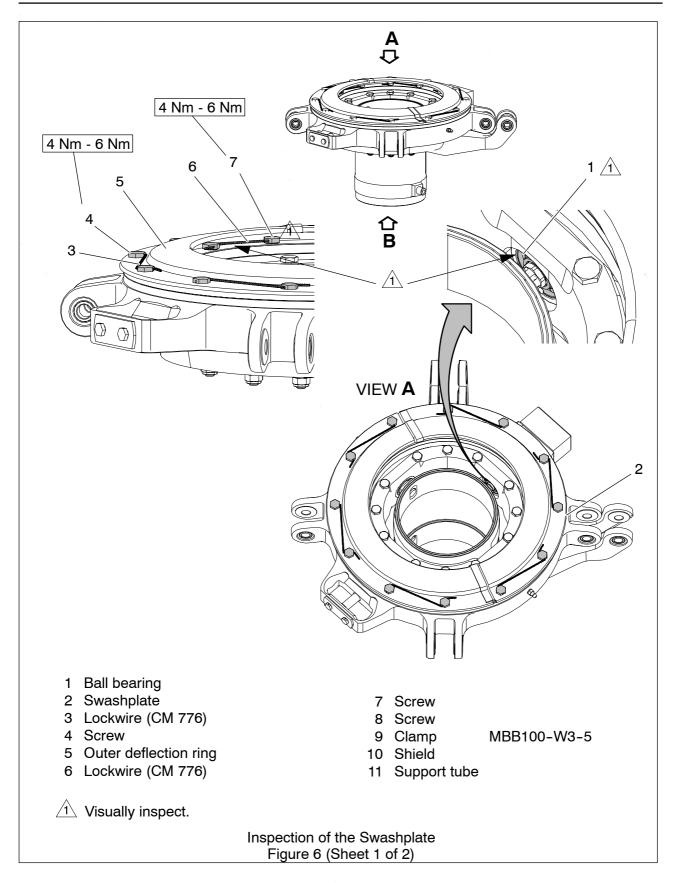
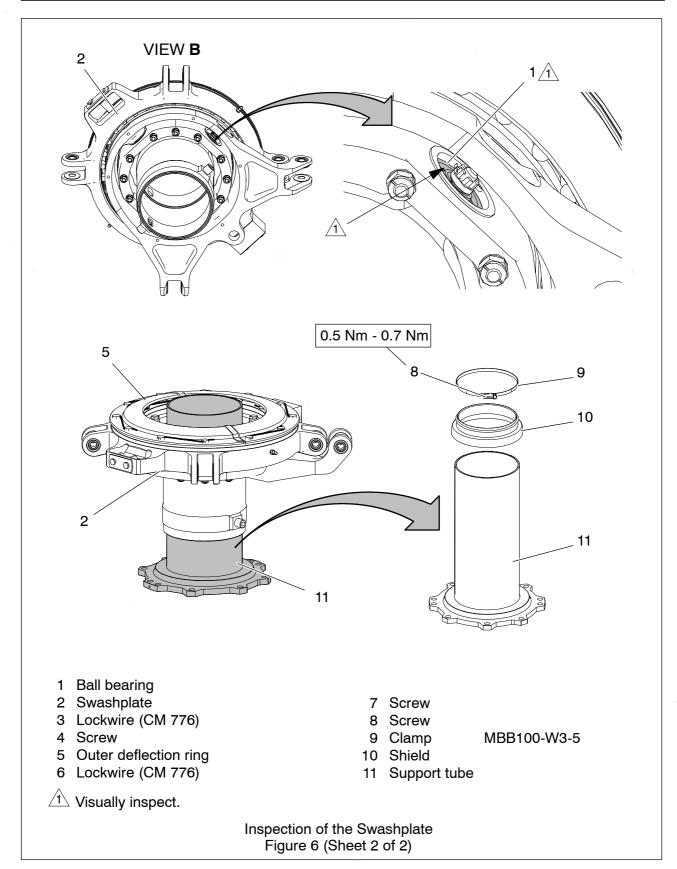
(h) Do the inspection of the support tube (11, Fig. 6) as follows:

**NOTE** In order to inspect the surface of the support tube (11, Fig. 6) use the collective lever to move the swashplate (2) up and down.

- 1 Clean the support tube (11, Fig. 6).
- 2 Examine the support tube (11, Fig. 6) for scratches.
  - If there are scratches, rework cylindrical area to a max. depth of 0.1 mm with polishing cloth #400. Reworked area must not exceed 10 mm in width, or 3 cm<sup>2</sup> in area. A minimum separation between any adjacent reworked areas must be 30 mm, and total reworked areas must not exceed 10 percent of the cylindrical area.

- (i) Do the inspection of the clamp (9, Fig. 6) for corrosion, damage and correct installation:
  - 1 Replace a corroded or damaged clamp (9, Fig. 6).
  - 2 If necessary install the clamp (9, Fig. 6) correctly on the shield (10).

- 3 Apply a torque between 0.5 Nm and 0.7 Nm to the screw (8, Fig. 6).
- (j) Do the inspection of the ball bearings (1, Fig. 6) as follows:
  - 1 Visually inspect the ball bearings (1, Fig. 6) for corrosion.

- 2 If the ball bearings (1, Fig. 6) show corrosion, contact AHD customer support.
- (k) Do the inspection of the area under the outer deflection ring (5, Fig. 6) as follows:

- 1 Remove the lockwires (3, Fig. 6) from the screws (4).
  - 2 Remove the screws (4, Fig. 6).
  - 3 Remove the outer deflection ring (5, Fig. 6).
  - 4 If there are foreign objects, remove the foreign objects.

- 5 Remove dirt with a lint-free cloth.
  - 6 Lubricate the swashplate bearing, refer to MM, 41-74.
  - 7 Install the outer deflection ring (5, Fig. 6) with the screws (4).

- 8 Apply a torque between 4 Nm and 6 Nm to the screws (4, Fig. 6).
  - 9 Safety the screws (4, Fig. 6) with new lockwire (CM 776) (3), refer to MTC, 20-02-06-402.

- (a) Do the inspection of the swashplate bearing, refer to MM, 41-73.
- (b) Lubricate the swashplate bearing, refer to MM, 41-74.
- (c) Do the inspection of the area under the outer deflection ring (5, Fig. 6) as follows:
  - 1 Remove the lockwires (3, Fig. 6) from the screws (4).
  - 2 Remove the screws (4, Fig. 6).
  - 3 Remove the outer deflection ring (5, Fig. 6).
  - 4 If there are foreign objects, remove the foreign objects.
  - 5 Remove dirt with a lint-free cloth.
  - 6 Install the outer deflection ring (5, Fig. 6) with the screws (4).
  - 7 Apply a torque between 4 Nm and 6 Nm to the screws (4, Fig. 6).
  - 8 Safety the screws (4, Fig. 6) with new lockwire (CM 776) (3), refer to MTC, 20-02-06-402.
